Journal section: Prosthetic Dentistry
 Publication Types: Research

The impact of restorative material and ceramic thickness on CAD\CAM endocrowns

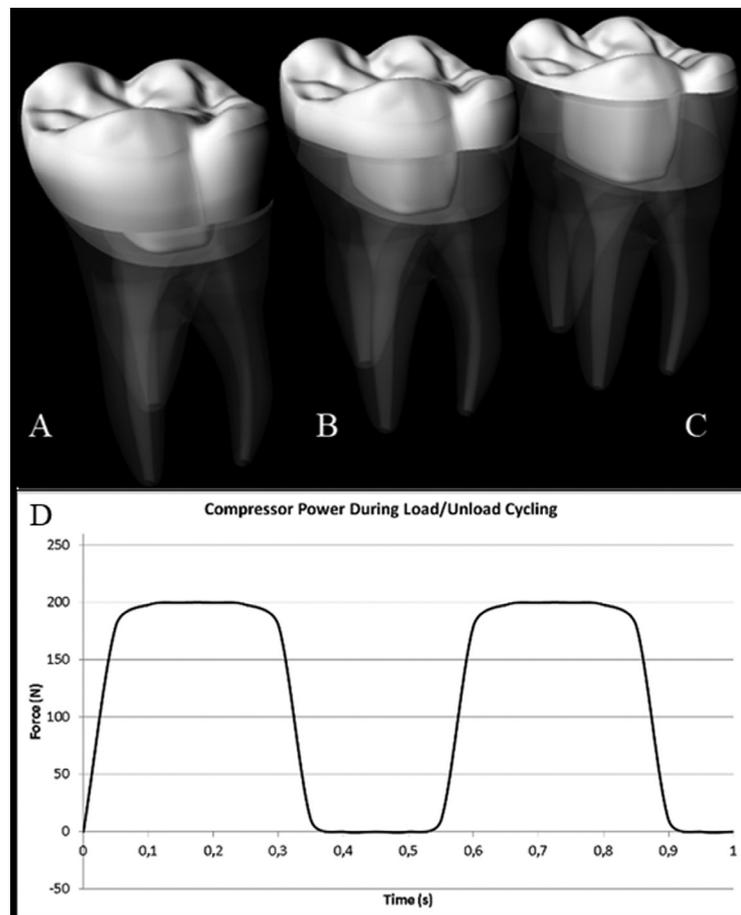
Fig. 1: Restoration minimum thickness and tooth remnant height. Subgroup 4.5 (A), 3.0 (B) and 1.5(C) with remnant tooth support of 1.5, 3.0 and 4.5 mm high, respectively. Fatigue test profile during mechanical cycling (D).

Next, each tooth was scanned (PlanScan; Planmeca) and the endocrowns restorations were generated in a CAD system (Romexis 4.5.0.R; Planmeca) with the requirements for full anatomic restorations of molar teeth. The materials used to design and manufacture endocrown restorations were leucite-based IPS Empress CAD (Ivoclar Vivadent AG) and lithium disilicate-based IPS e.max CAD (Ivoclar Vivadent AG). The difference between the groups followed a ratio of 1.5 mm in the three chosen restoration thicknesses (Fig. 1). Restoration mi-

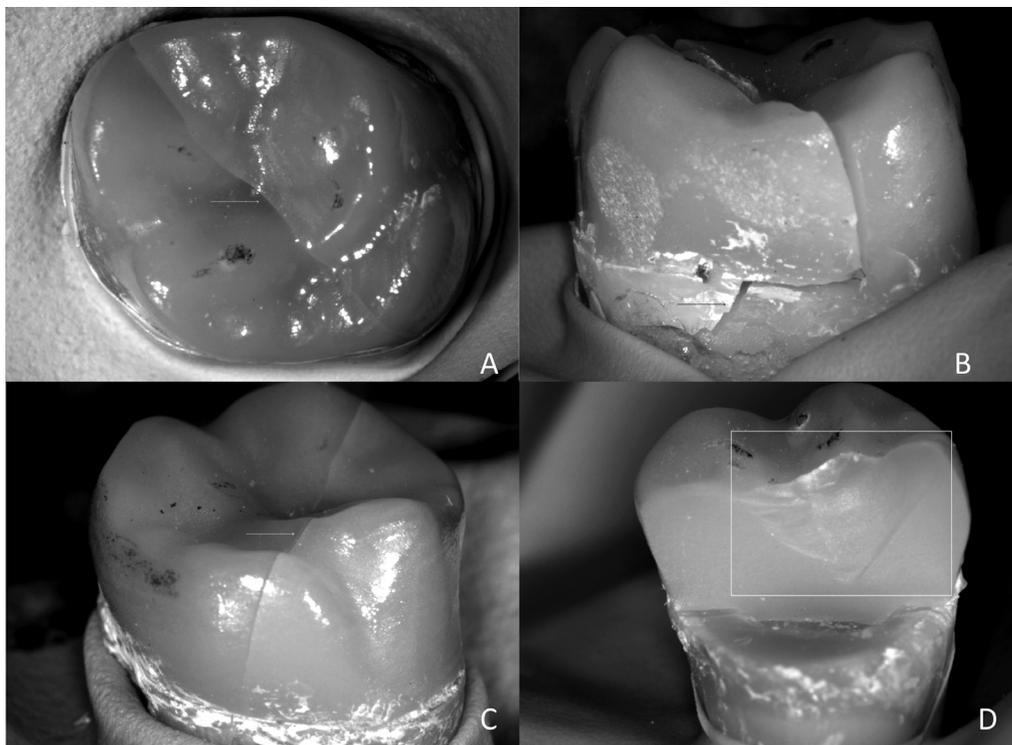
Fig. 2: Endocrowns failure analysis view assessment revealing (A-C) the bulk failure profile separating the crown into two main pieces (white arrows) even involving dental fracture (black arrow), and (D) an overview (stereomicroscopy) of fractographic marks suggesting the crack propagation from the occlusal surface.

According to failure analysis, the crowns predominantly failed by bulk fracture. Two fracture modes with different numbers of main fractured pieces were observed. Fractures extended along the mesio-distal plane occurred in 85% of the specimens, separating the crown into two main pieces. Fractures extended further to the lingual groove in the 15% of the crowns, resulting in three main fractured pieces (Fig. 3). Representative failure samples were then submitted to scanning electron

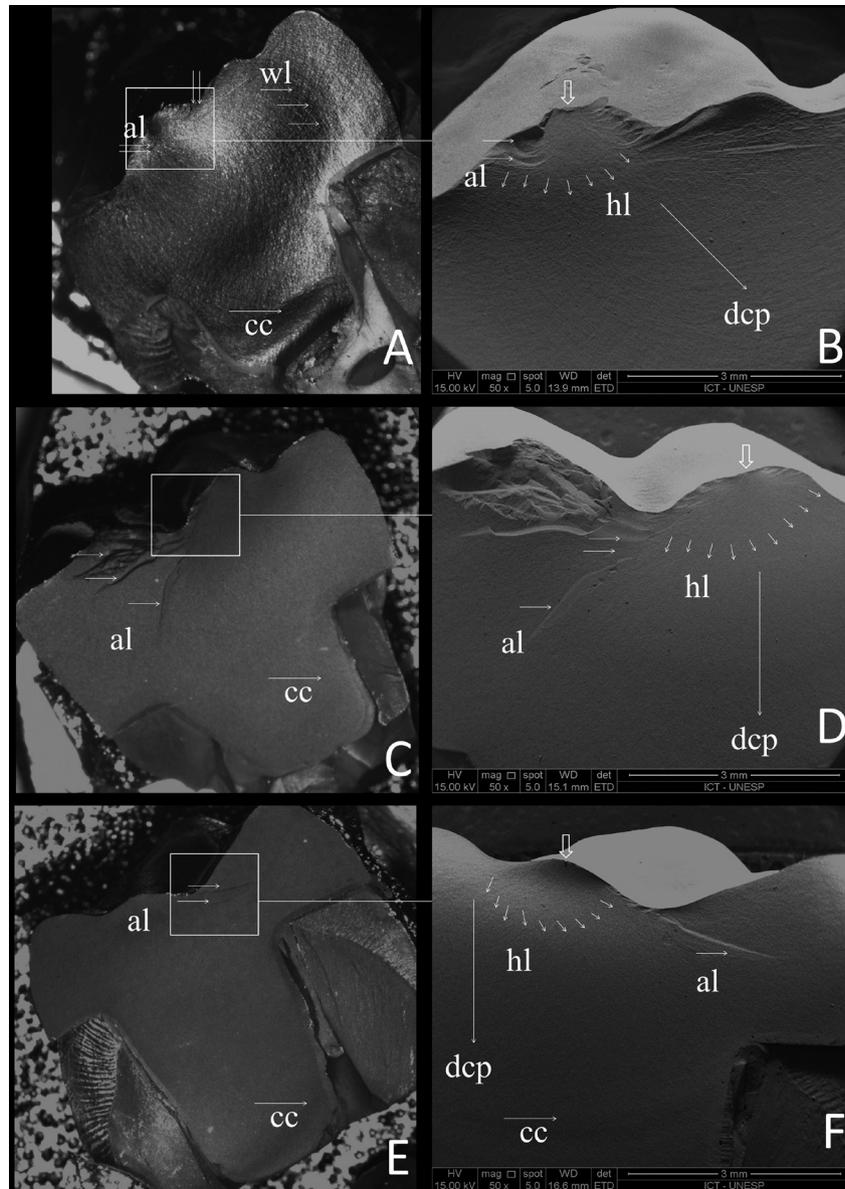
Fig. 3: Fractography analysis of the endocrown restorations. (A, C and E) Stereomicroscope pictures (25x) of the reassembled fractured specimen. SEM (50x) micrographies (B, D and F) shows the loading damage detected on the occlusal surfaces of the restoration where the failure origin was located. The white squares show the origin of the fracture at the contact points. Hackel lines (hl), walner lines (wl) and arrest lines (al) are indicating the direction of crack propagation (dcp) and the compression curl (cc) was observed at the bottom of the restoration.

Each fractured crown was visually inspected at 25x magnification (Zeiss Discovery V20; LLC) (Fig. 3). One representative sample of each group was inspected by using a scanning electron microscope (Inspect S50; FEI). The specimens were sputter coated with gold for 180 s at 40mA, creating a 30nm-thick layer. This was examined under different standard SEM magnifications operated at 20KV with secondary electron detection by a single operator.

microscopy (SEM) for further investigation of failure origin. Fractographic analysis revealed that the fracture origin was always at the occlusal surface in all fractured restorations, mainly from the major contact loading area, underneath the indenter and corono-apically propagated.

According to the fractographic analysis, the fractures respected a failure pattern due to the load application. The failure origin occurred on the restoration's external surface in the indenter contact region. Hackle lines are identified in the SEM images and indicate the crack propagation direction from the top to bottom. Under this study's limitations, lower molars restored with the endocrown modality by using different materials and thicknesses showed greater fracture strength. However, these results may not be clinically significant since the failure load data are higher than the normal mean values of masticatory load (53). Therefore, future clinical investigations should be developed to investigate the *in vivo* performance of endocrowns.
